HUDSON RIVER BASIN
LONGHOUSE BROOK
PASSAIC COUNTY
NEW JERSEY

LOOKOVER LAKE DAM

NJ 00565

PHASE 1 INSPECTION REPORT NATIONAL DAM SAFETY PROGRAM

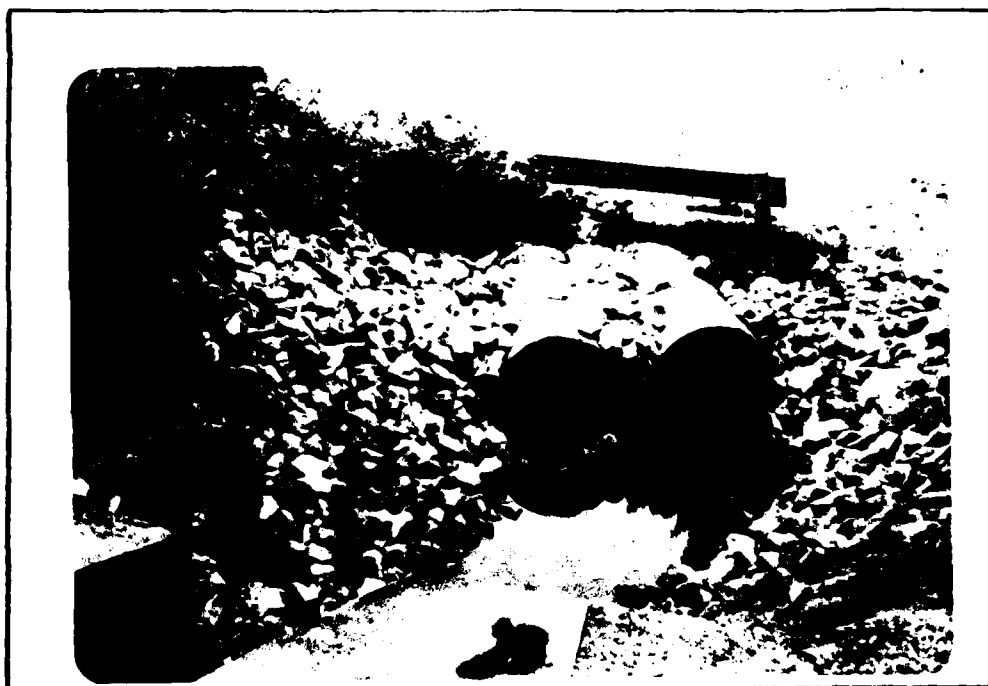
c. Visual Observations. On the dates of the inspections, the entrances to the 36-inch diameter reinforced concrete pipes were partially blocked with dumped rock. This situation would not directly affect the dam, but it could cause overtopping of the Cherry Ridge Road downstream of the dam during periods of high flow.

11. ROCKS PARTIALLY BLOCKING CULVERTS BENEATH
CHERRY RIDGE ROAD. (5/28/80)

6. UNCLOG THE DOWNSTREAM ROAD CULVERTS AND REPLACE THE EXISTING CULVERTS WITH ONES OF THE PROPER SIZE.
